**DELAWARE RIVER BASIN
MARSHALL FALLS CREEK, MONROE COUNTY
PENNSYLVANIA
NDS ID PA. 00636
DER ID 45-116**

**WHITE HERON DAM
(MINISINK LAKE)**

**PHASE I INSPECTION REPORT
NATIONAL DAM INSPECTION PROGRAM**

APRIL 1979

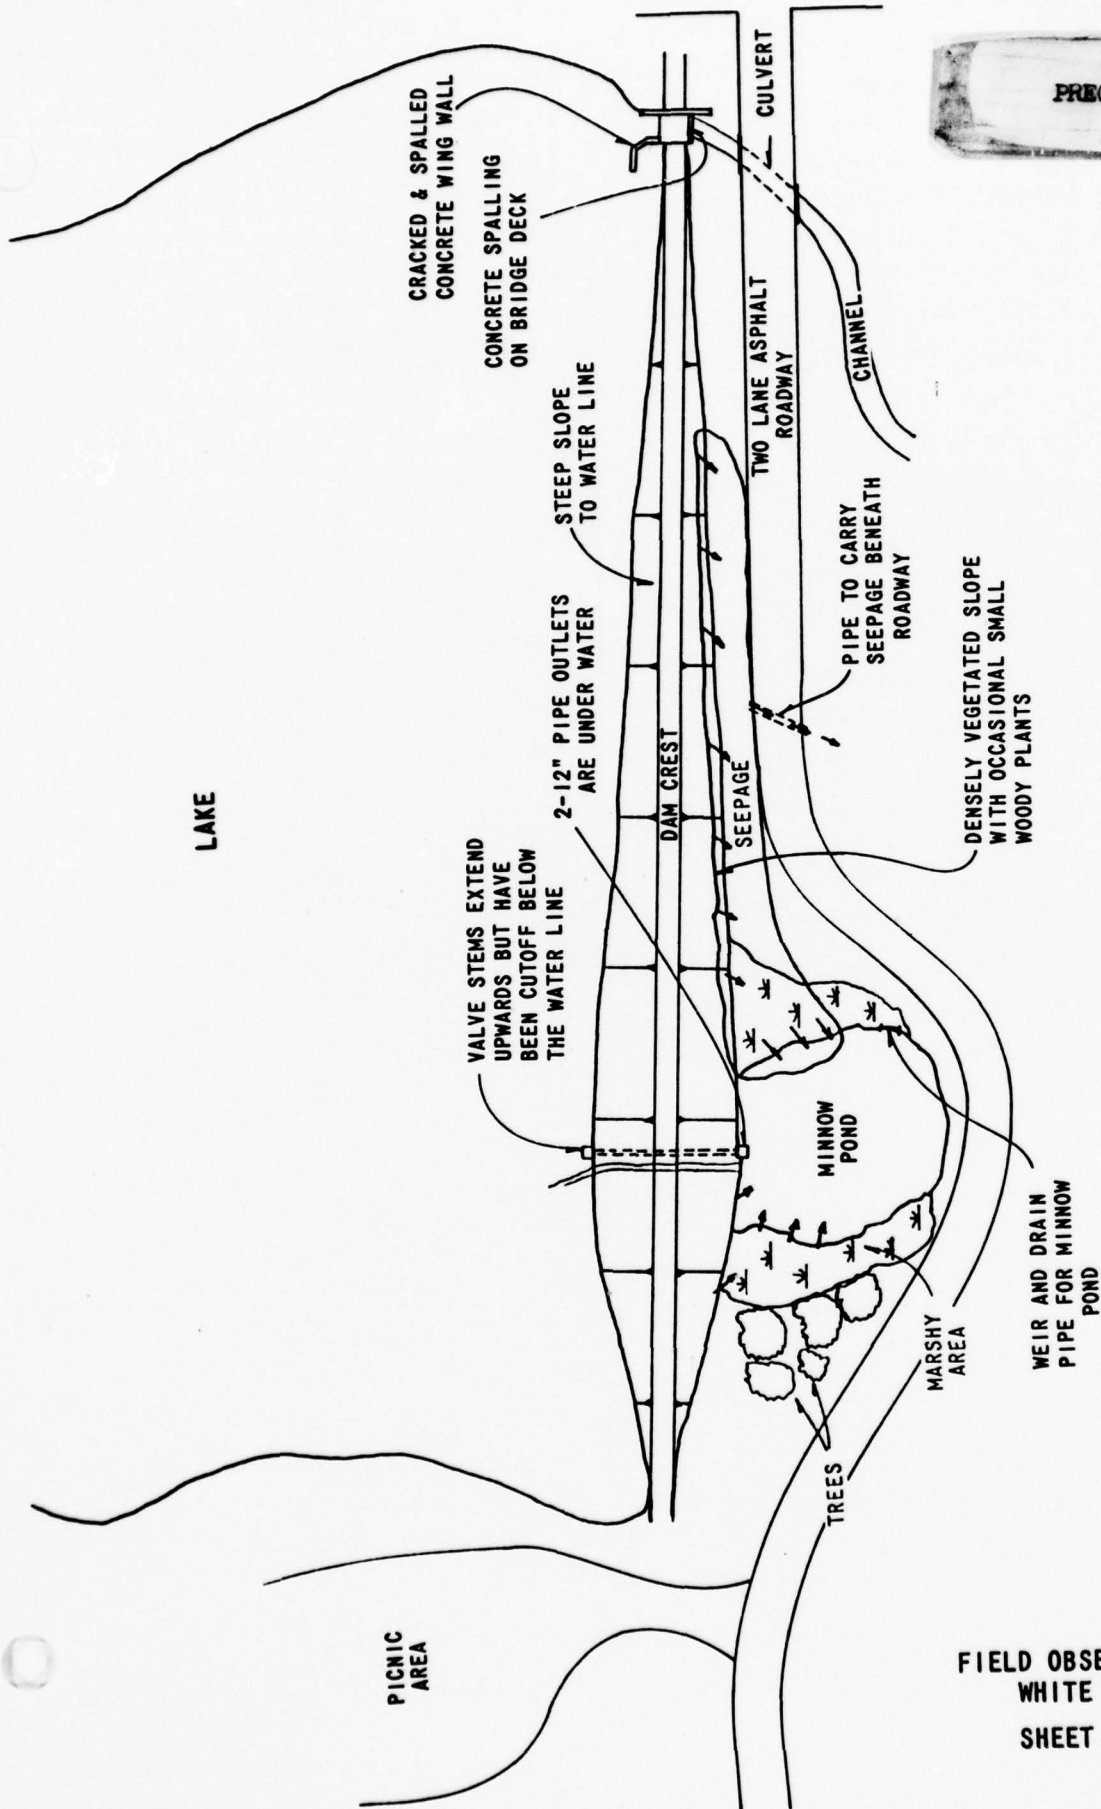
FIELD OBSERVATION PLAN
WHITE HERON DAM
SHEET 5a OF 11

Clear seepage was noted along most of the downstream toe with cattails growing along the toe between the dam and the access road. Several other damp elliptical areas were noted near the base of the downstream slope ranging up to 15 feet across and containing fern growth. Several of these elliptical areas are depressed, showing evidence of past movement.

Yes See Sheet 5a. Seepage was noted along most of the toe and there are cattails growing along the toe between the dam and access road.

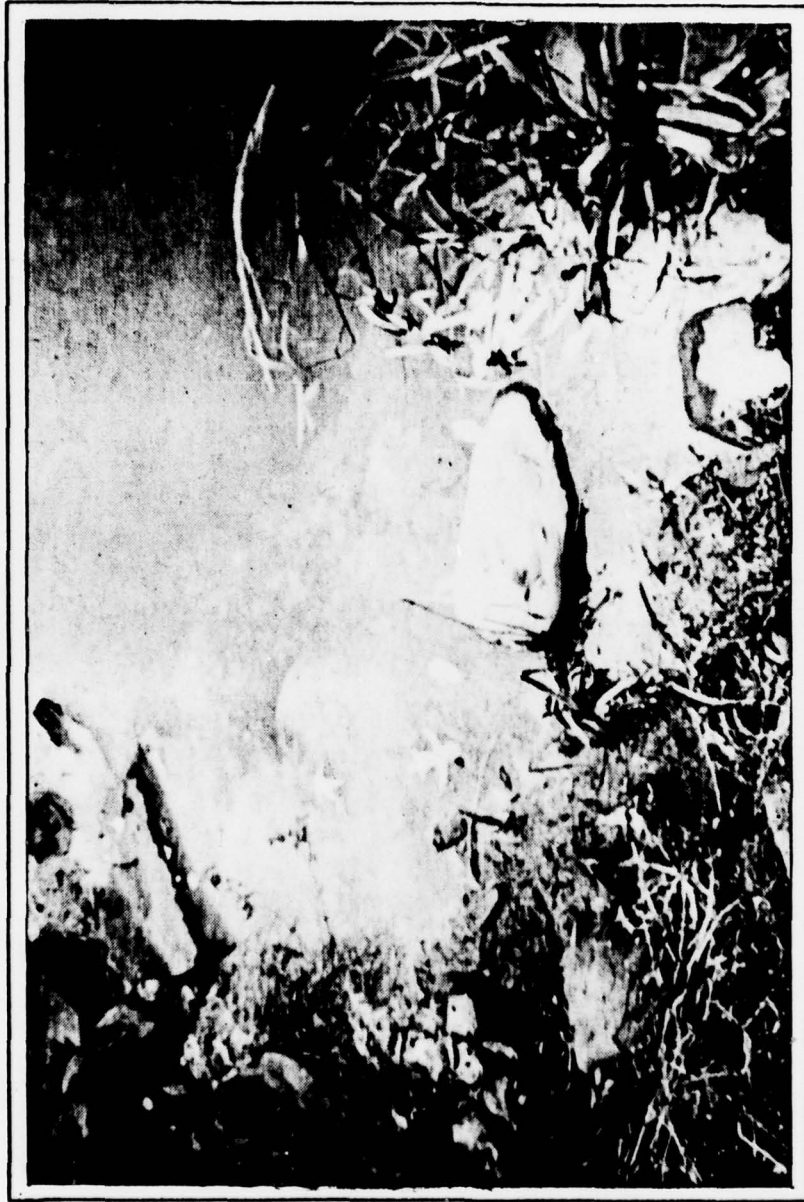
PHOTOGRAPH NO. 2

DISCHARGE PIPES AT EDGE OF POND
JUST BELOW WATER LEVEL. SEE
PHOTOGRAPH 1.

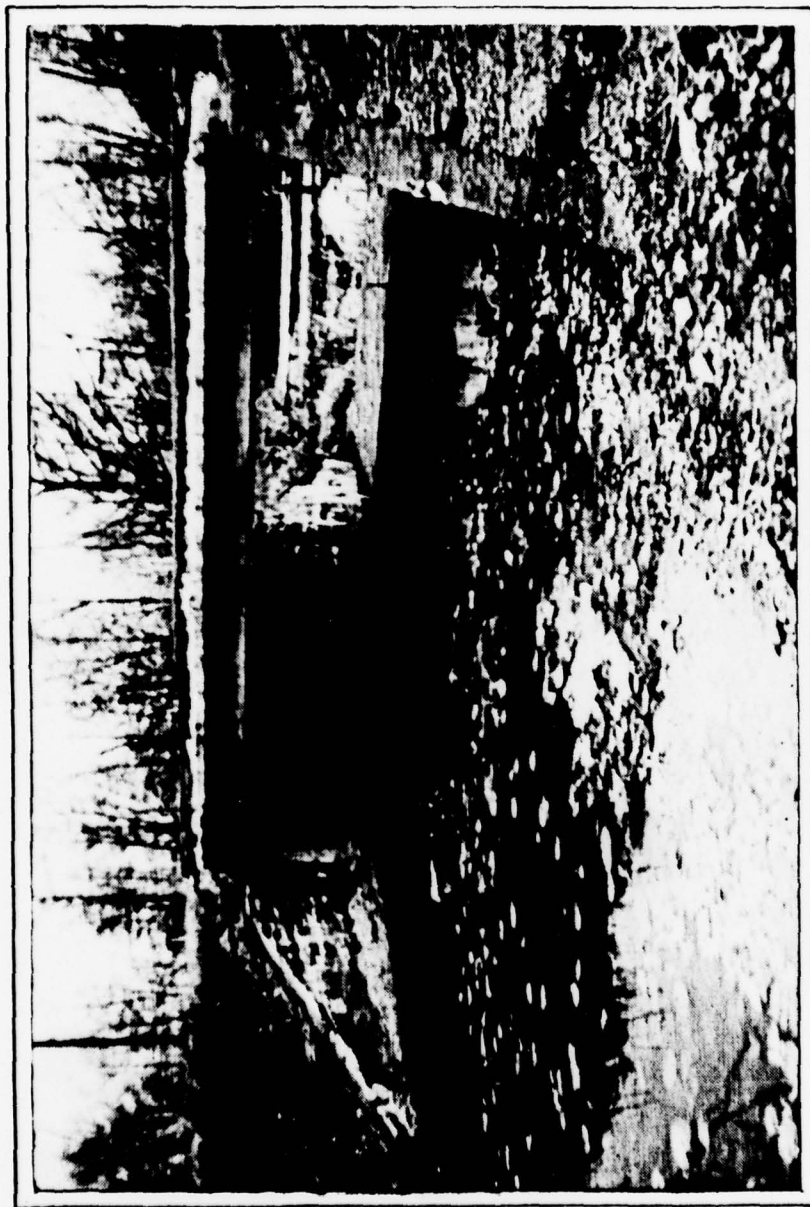
PHOTOGRAPH NO. 4

Fair condition with some spalling of weir crest. Flash boards have been used in the past to raise the lake level by about six inches. It was reported that flash boards are no longer used.

VIEW OF SPILLWAY WEIR AND BRIDGE.

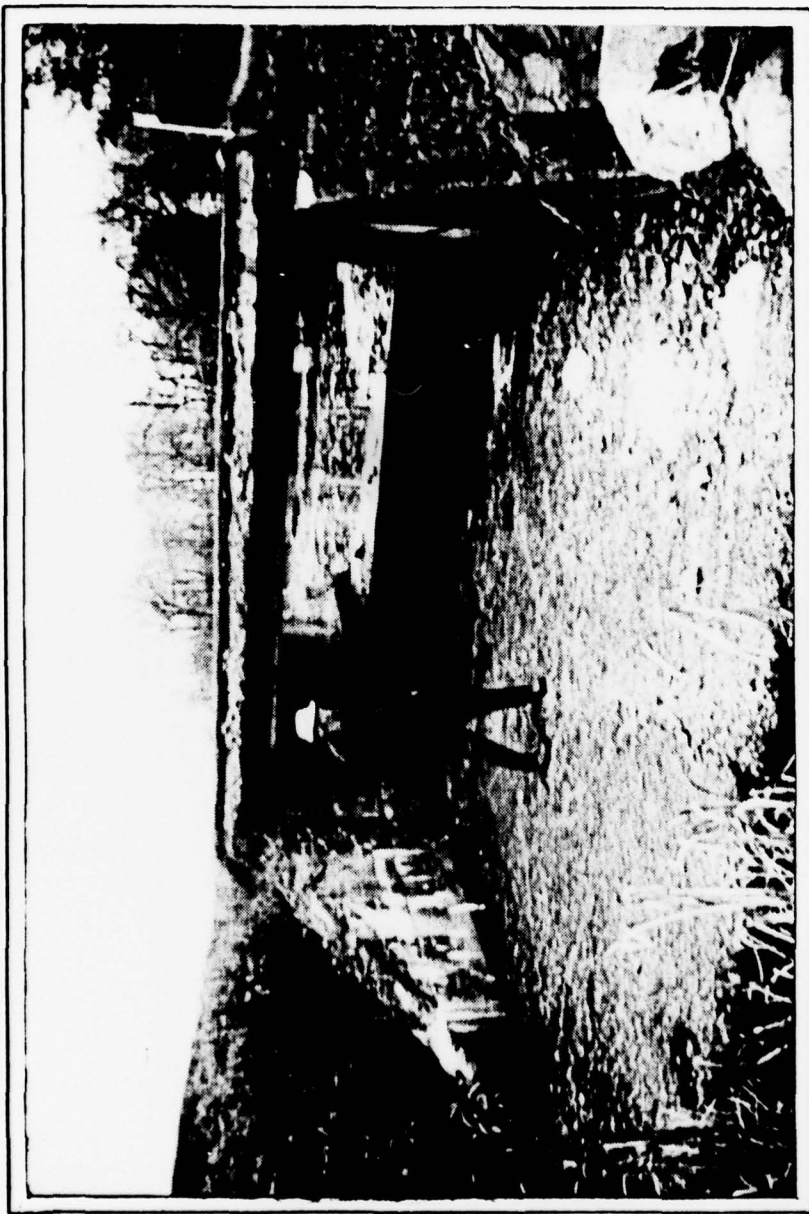
PHOTOGRAPH NO. 5

VIEW LOOKING UPSTREAM TOWARDS
SPILLWAY.

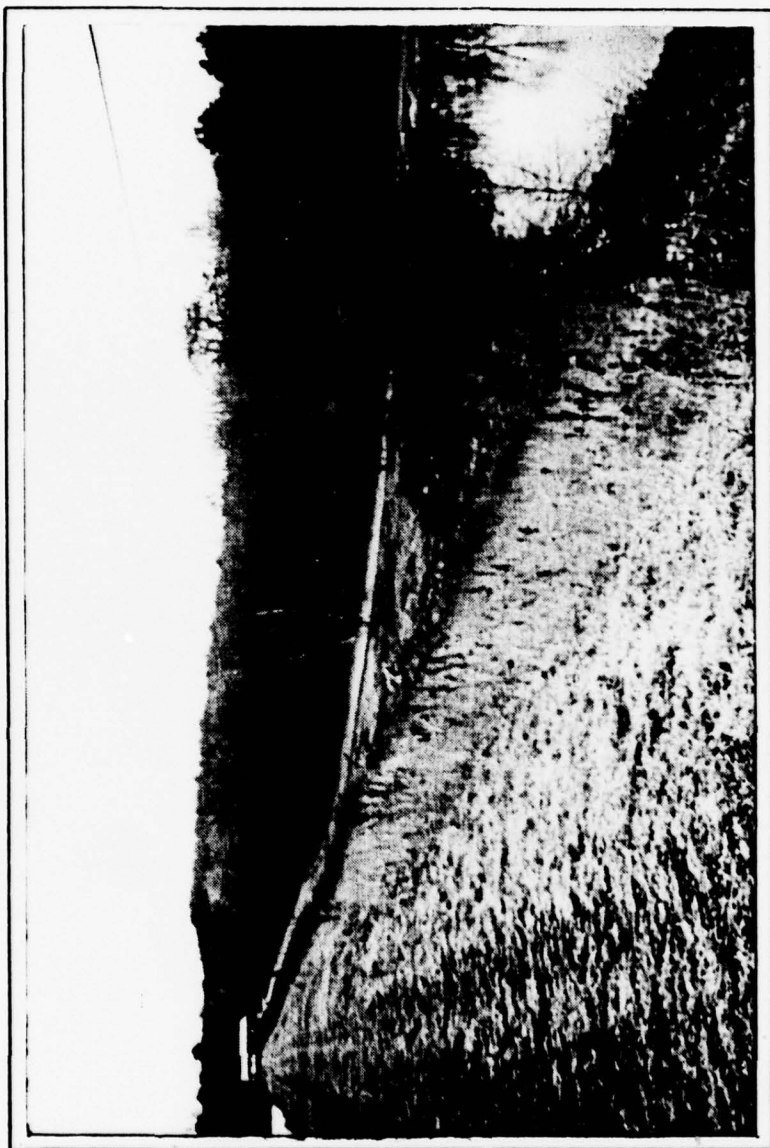
PHOTOGRAPH NO. 8

VIEW OF DOWNSTREAM SLOPE LOOKING
FROM RIGHT ABUTMENT.

1. The downstream slope should be stripped of all woody vegetation and erosion gullies repaired.
2. Riprap on the upstream slopes should be cleared of vegetation and rehabilitated in accordance with recommendations by a registered professional engineer.
3. The pond drain system should be tested and rehabilitated as necessary so as to be operational.
4. Seepage should be measured and evaluated. Appropriate remedial measures, if necessary, should be implemented as recommended by a registered professional engineer.
5. The embankment crest should be regraded to design elevation using impervious materials. The materials should be placed in accordance with the recommendations of a registered professional engineer.

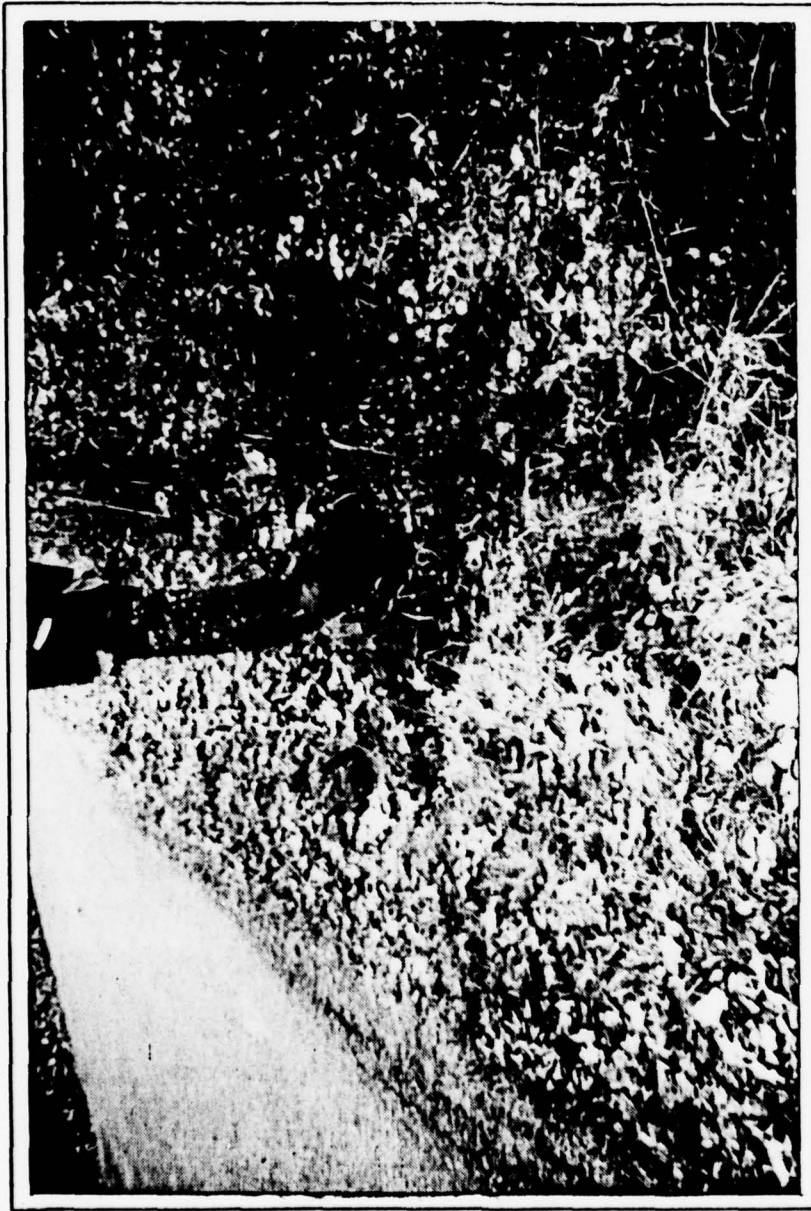
PHOTOGRAPH NO. 9

SEEPAGE ALONG DOWNSTREAM TOE AT
LEFT END OF DAM.

1. Piezometers or observation wells should be installed along the crest and along the downstream slope to determine the location of the phreatic surface.
2. Undisturbed samples should be taken through the embankment and foundation and tested to evaluate the physical and engineering properties of the embankment and foundation materials.
3. Data collected in steps 1 and 2 should be used to evaluate the stability of the embankment.

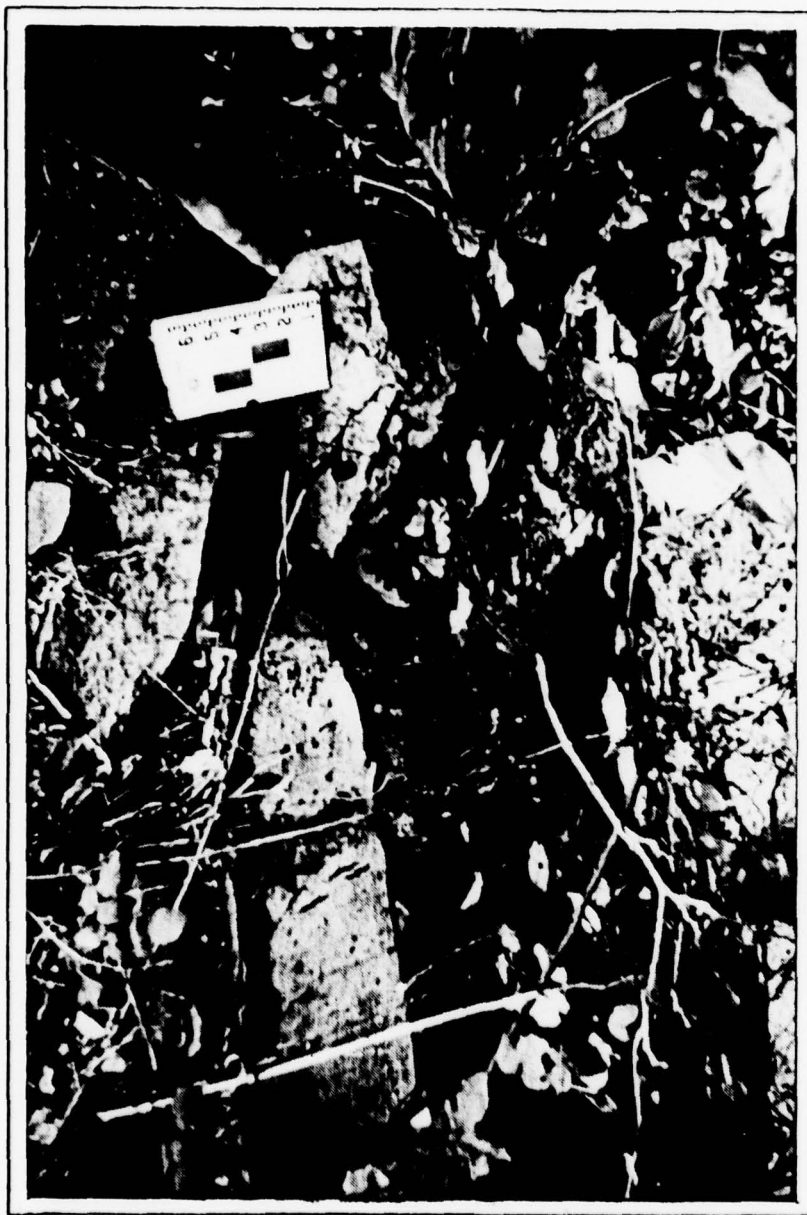
PHOTOGRAPH NO. 10

CLOSE-UP VIEW OF EMBANKMENT SEEPAGE.

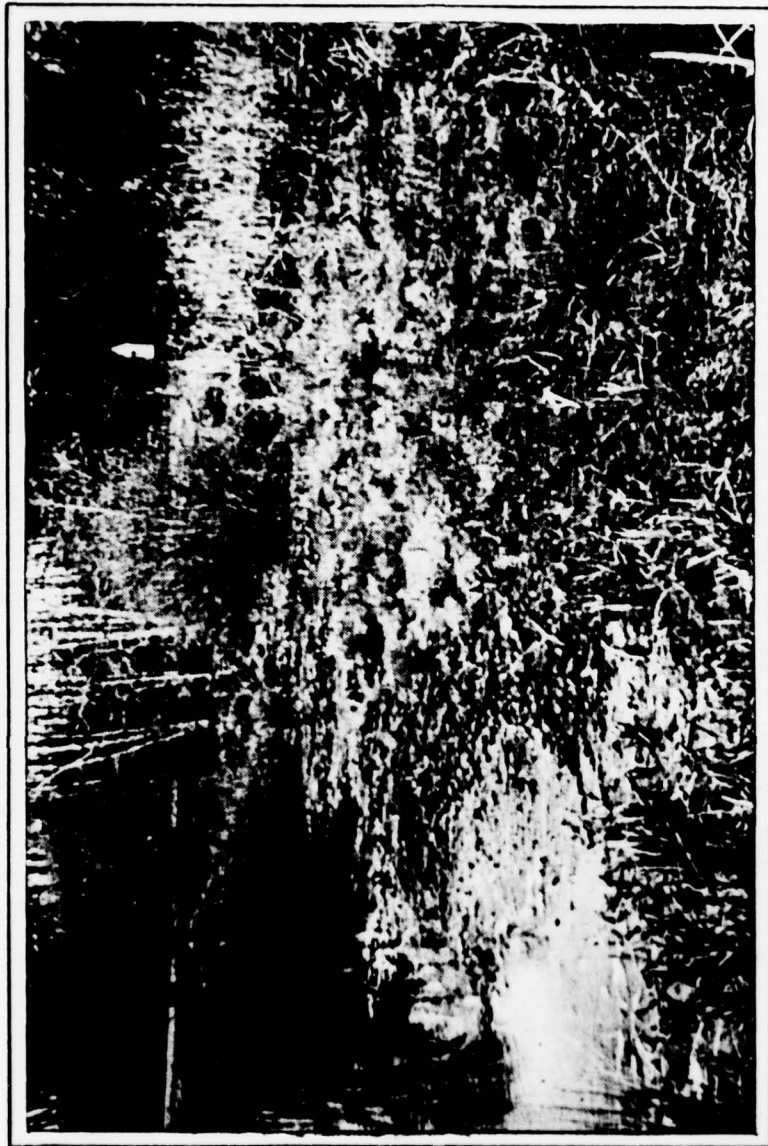
PHOTOGRAPH NO. 11

VIEW OF EMBANKMENT SEEPAGE JUST RIGHT
OF POND DRAIN OUTLET PIPES. NOTE
GENERAL MARSHY CONDITION.

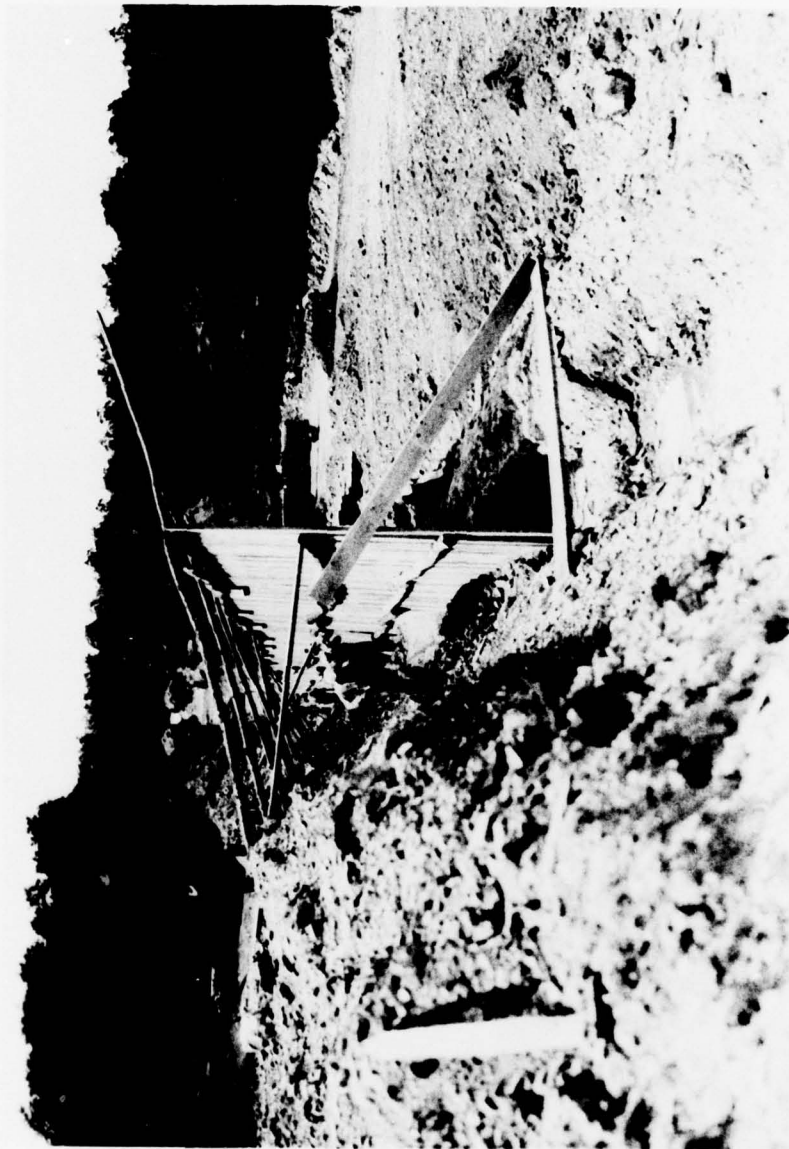
PHOTOGRAPH NO. 12

1929 CONSTRUCTION PHOTOGRAPH SHOWING
WOODEN CUTOFF WALL AND BACKFILL
TECHNIQUE.
